# GENERAL ECO RUBBER PRESENTATION

**SMALL ROOFS**

# LEAKY ROOF ON INSPECTION

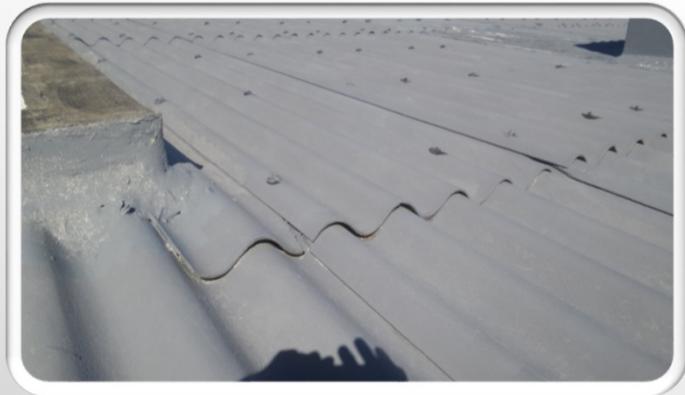
MISALIGNED ROOF SHEETS – BIG GAPS  
CRACKED AND LOOSE 'LAP EN PAP'  
LENGTH CRACKS IN VARIOUS PLACES

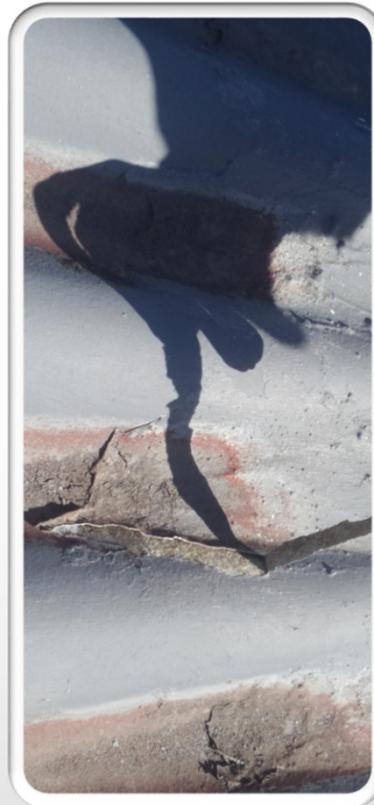
PONDING AT CHIMNEY ROOF SEALING  
WITH DAMP LOOSE PAINT SKIN – ALL  
RAIN WATER TRAPPED

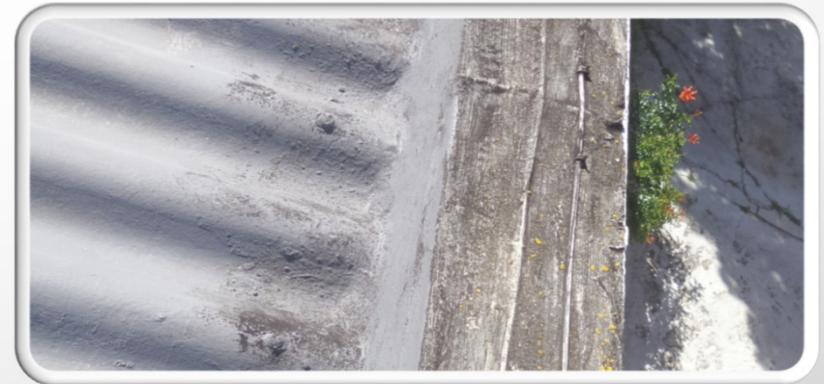
ROOF PAINT AND LAP – DRIED OUT AND  
CRACKED OR BUBBLING, ALSO LOOSE IN  
PLACES

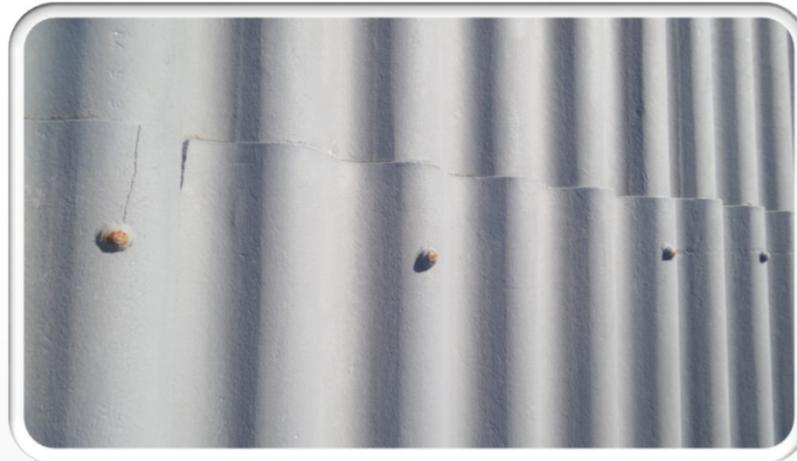
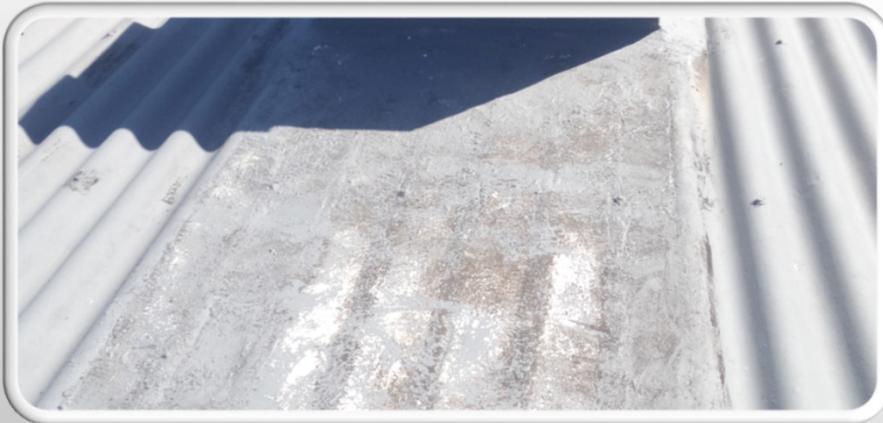
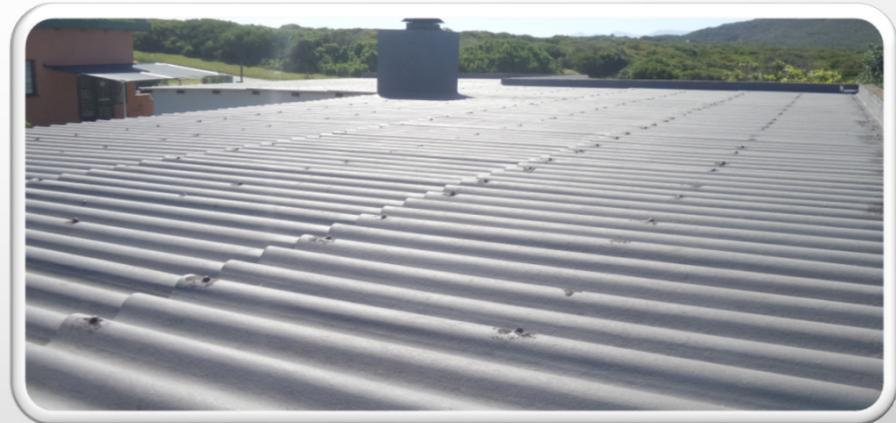
RUSTED BOLT HEADS – SOME LOOSE, CRACKED ROOF SHEETS, PARAPET LEAKS – DRIED AND CRACKED, PONDING, LOOSE PAINT AND LAP.
