# Typical Failure on Metal Roofs

Photo Record

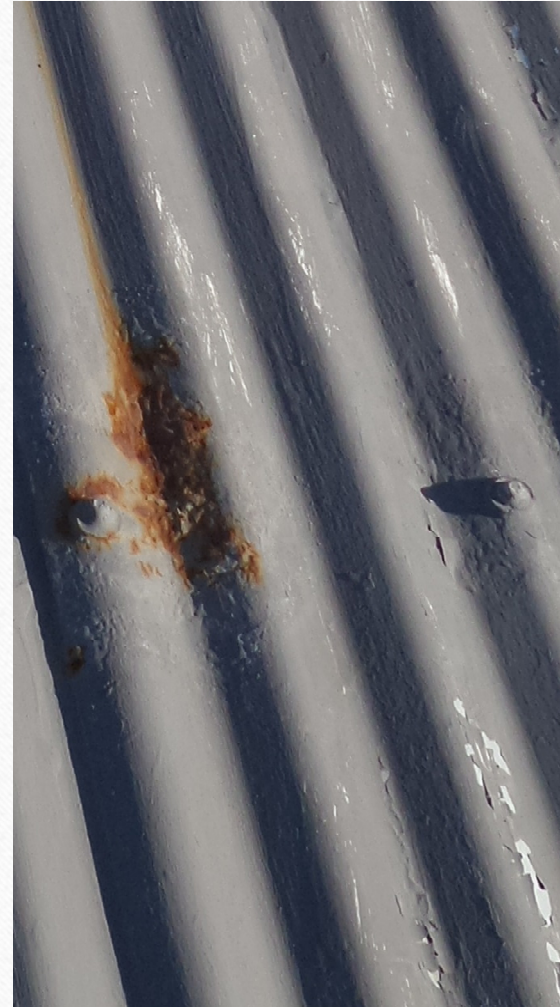
- Rust
- Vertical Cracks
- Blistering
- Roof Bolts

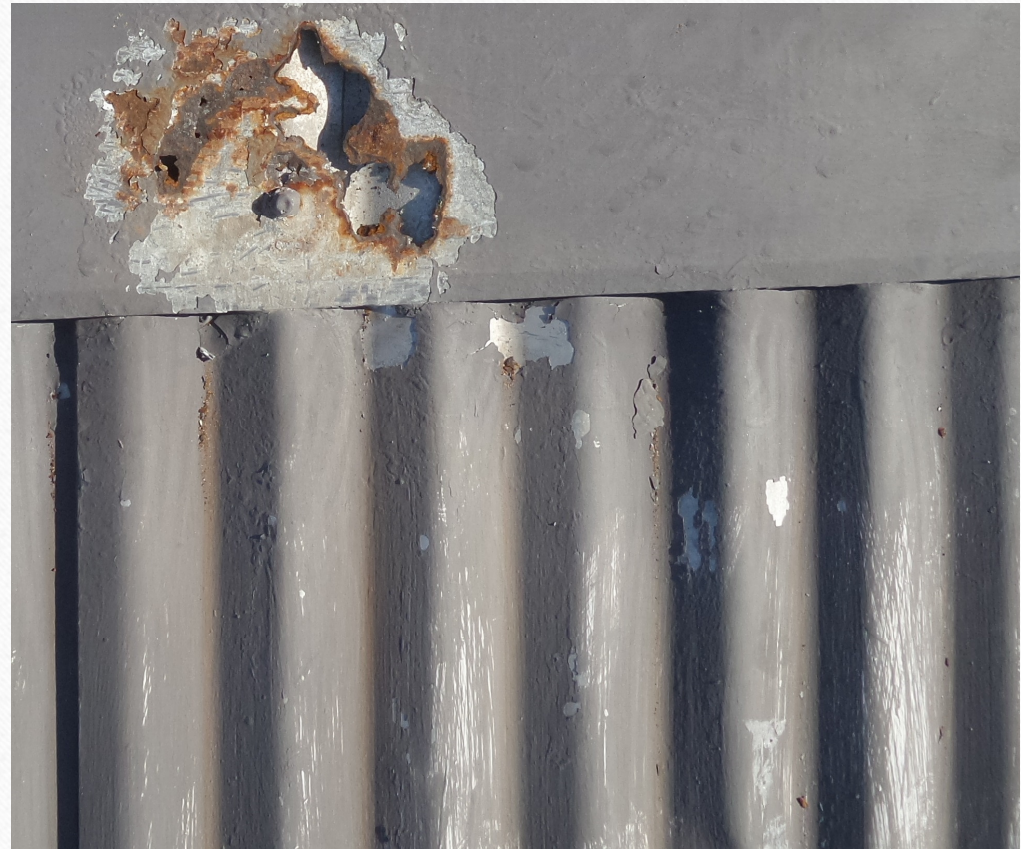
- Rust on Ridge Cap
- Blistering
- Unkeyed Brush marks
